European House Borer

The European House Borer is a destructive pest that causes severe damage to seasoned untreated coniferous timber. New importation requirements have been introduced to protect Victoria from this pest.

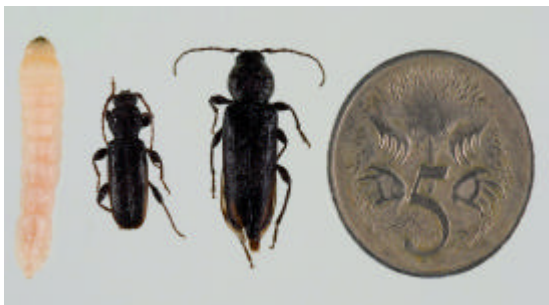
Picture: (from left) EHB larva, male and female beetles

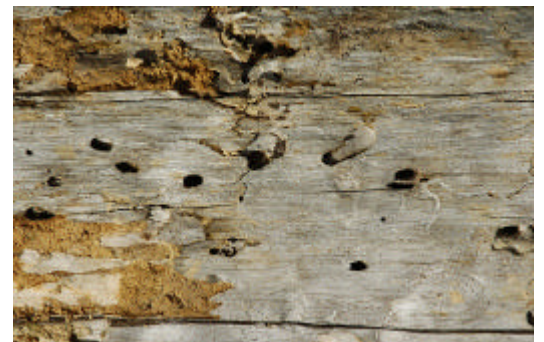
- **Oval shaped emergence holes** - (5-10mm) running with the grain of infested timber from which the adult beetle has emerged.
- **Adult beetles** that are brown/black in colour and 8-25mm in length. They usually emerge from wood in spring/summer.
- **Frass** - This is the droppings of EHB mixed with fine wood dust. This is often found on the ground just below where the adults beetle has emerged.
- **Blisters** - Long blister-like swellings under the surface of a thin layer of uneaten wood where the borer has eaten a gallery (tunnel) through the wood and tightly packed it with frass.
- **A soft scraping sound** - this is made by larvae as they feed and can often be heard at night.

Picture: EHB emergence holes (running with the grain of the wood) and blisters caused by frass

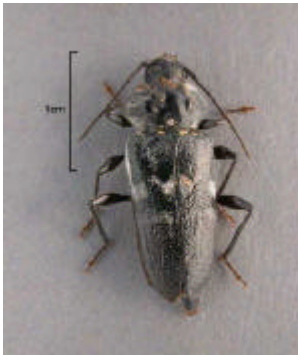
The Adult Beetle - is brownish / black in colour and has a slightly flattened appearance. The wings are usually black and sometimes may have small white markings. Adults are about 8-25mm in length with antennae about half as long as the body. They can lay up to 120 eggs into crevices or cracks in timber.

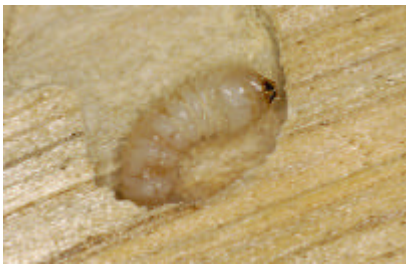
EHB Larvae - are elongated and cylindrical with an enlarged and flattened head. The length varies up to 41mm and about 7.5mm wide at maturity.

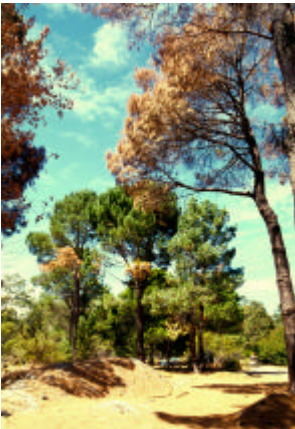
Pine Tree - This shows a dead pine tree which is susceptible material, in and amongst live pine trees. Even dead branches or dead veins in live wood are potential host material.

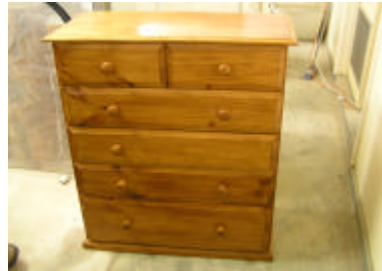
Pine Draws - EHB has also been detected in untreated pine furniture
